GE Generator Rotor Retaining Rings: Experience and Fleet Data

Ronald J. Zawoysky
GE Power Systems
Schenectady, NY

SUMMARY

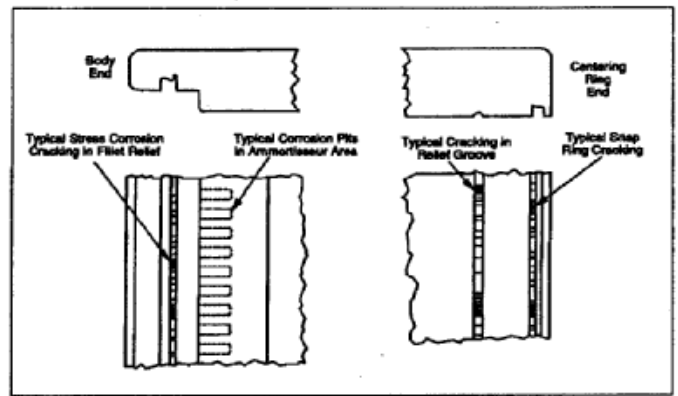
GT18066

Recent results have consistently shown that the inside diameter of the retaining rings is much more vulnerable to stress corrosion cracking. In general, 18Mn-5Cr retaining rings that have been inspected from the outside diameter with the retaining rings in place have not been found to have a large number of indications.

When the cooling flow for the generator field is examined, it becomes apparent why the inside diameter of the field is more vulnerable. The cooling medium (air or hydrogen) is directed under the retaining rings from both ends of the field and contaminants and moisture can be

trapped under the retaining rings. The only way to ensure that 18Mn-5Cr retaining rings do not have stress corrosion cracking or pitting is to inspect all surfaces of the rings using eddy current and fluorescent penetrant techniques (Figures 5 and 6).

Figure 5. Body-mounted retaining ring schematic; typical indications found on inside diameter of rings

- In the interim, inspect, protect and repair 18Mn-5Cr retaining rings per the recommendations of TILs 1001-3 and TIL 1097-3. To ensure the best confidence of a ring being stress corrosion free, the entire retaining ring, both inside and outside diameters, should be tested using eddy current and fluorescent penetrant techniques. It should be noted that even if an 18Mn-5Cr retaining ring is found free of stress corrosion cracking, experience has shown that there is no guarantee against subsequent stress corrosion cracking and an in-service retaining ring failure.

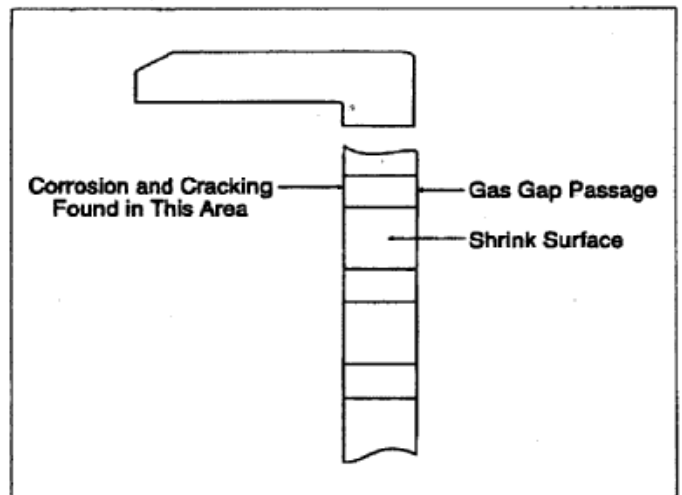
GT22368

Figure 6. Spindle-mounted retaining ring; typical indications found on inside diameter
