# HRSG Tube Restraints Upgrade

For Robust Design and Improved Reliability

GEA34555 02/2020

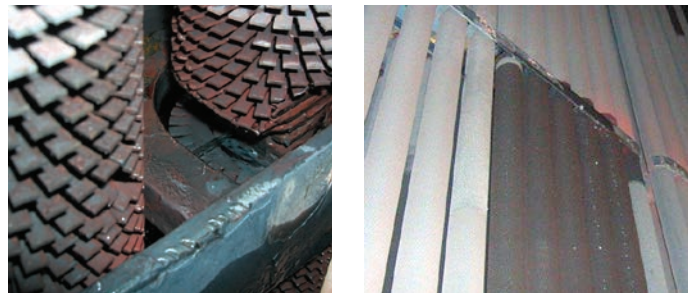
Figure 2: Leaking Tubes from Damaged Restraints
