GE VERNOVA

# UR Family

## Release Notes

Publication Number: GER-4882G

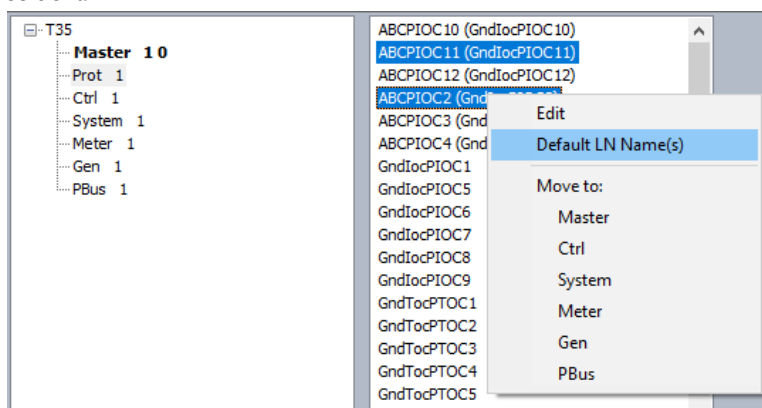
Description: The IEC 61860 > Edit Data Model window in the software includes right-click "Default LN Name(s) in this LD" and "Default LN Name(s)" options. Users can now change the prefix and instance number of a configured logical node to default values using the "Default LN Name(s)" command. In addition, when the default prefix or instance number of a logical node is changed, the window shows the default LN name beside it.
