## UR Family

# Version 8.0x

## Release Notes

GE Publication Number: GER-4882G

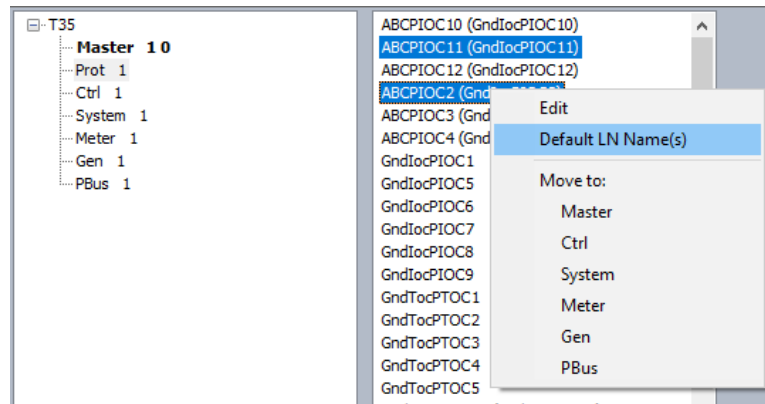
Description: The IEC 61860 > Edit Data Model window in the software includes right-click "Default LN Name(s) in this LD" and "Default LN Name(s)" options. Users can now change the prefix and instance number of a configured logical node to default values using the "Default LN Name(s)" command. In addition, when the default prefix or instance number of a logical node is changed, the window shows the default LN name beside it.
