UR Family

Bootloader 7.05 for CPU without Interface to Graphical Front Panel

Release Notes

GE Publication Number: GER-4904B

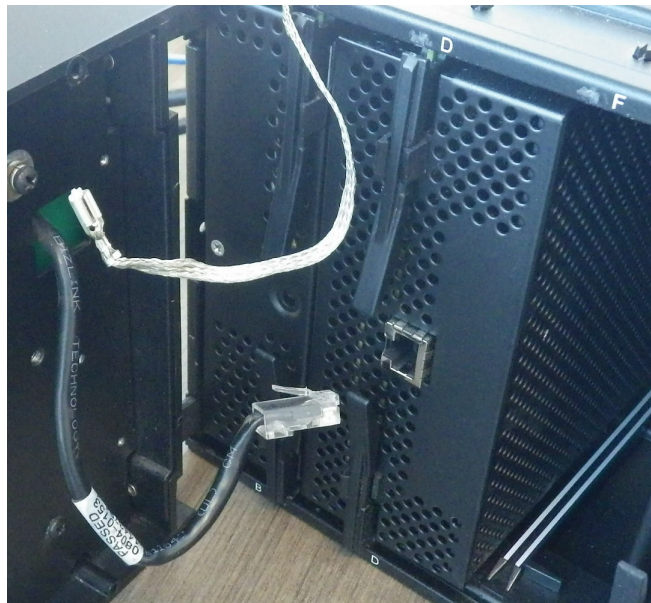
Figure 1: No connector available on the CPU module for a graphical front panel
