UR Family

Bootloader 7.06 for CPU with Interface to Graphical Front Panel

Release Notes

GE Publication Number: GER-4905B

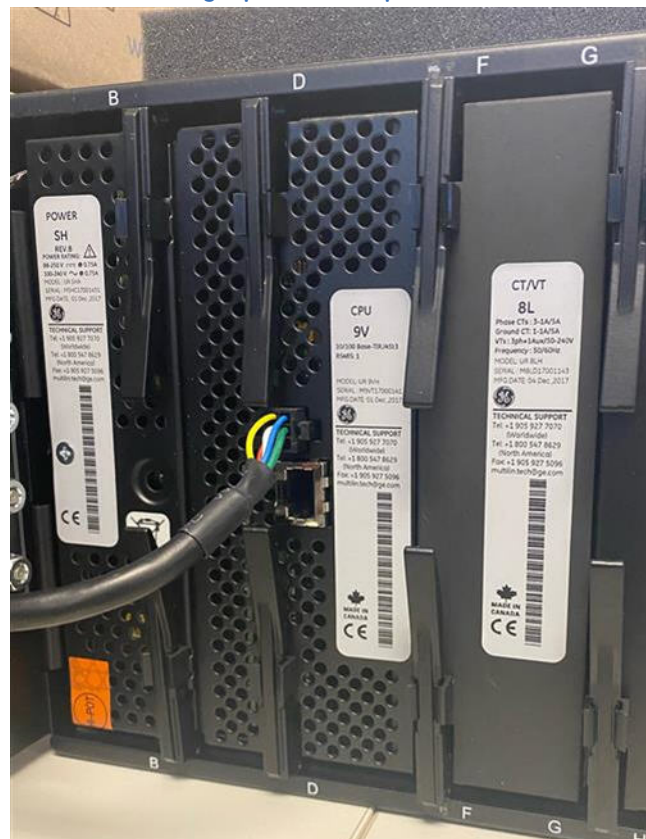
This document contains the release notes for bootloader version 7.04 and 7.06 for the GE Universal Relay (UR) family of products. It applies to a relay's Central Processing Unit (CPU) module with an interface to a graphical front panel. This CPU module is identifiable by the two connector slots on the front.

Figure 1: Black connector for graphical front panel above chrome connector
