GE VERNOVA

## UR Family

## Version 8.1x

## Release Notes

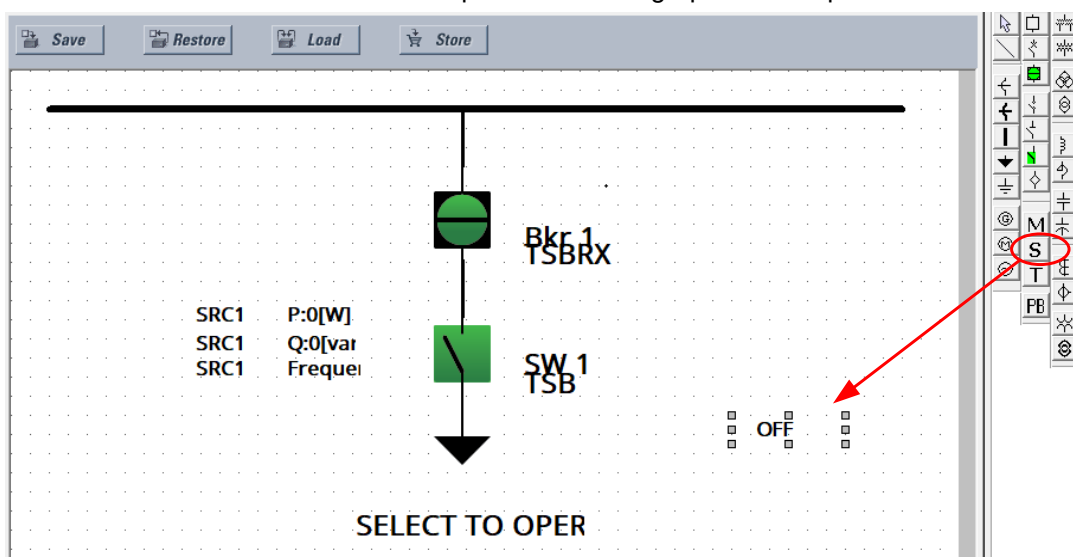
Description: Users can add Status components to graphical front panel screens by using the Single Line Diagram Editor windows in the EnerVista UR Setup software. After synchronizing these screens to the UR, the graphical front panel shows the actual status value for each of the Status components. In previous versions, this is achieved by adding/editing Status components in the single-line diagram screen of an online device, not when adding/editing the components in offline devices that were subsequently synchronized to UR.

In the new release, this configuration is included in CID files, allowing relays to show the actual status value for each of the Status components in their graphical front panel screens.
