HRSG Casing, Insulation, Liner Upgrade

For Robust Design and Improved Reliability

GEA34554 02/2020

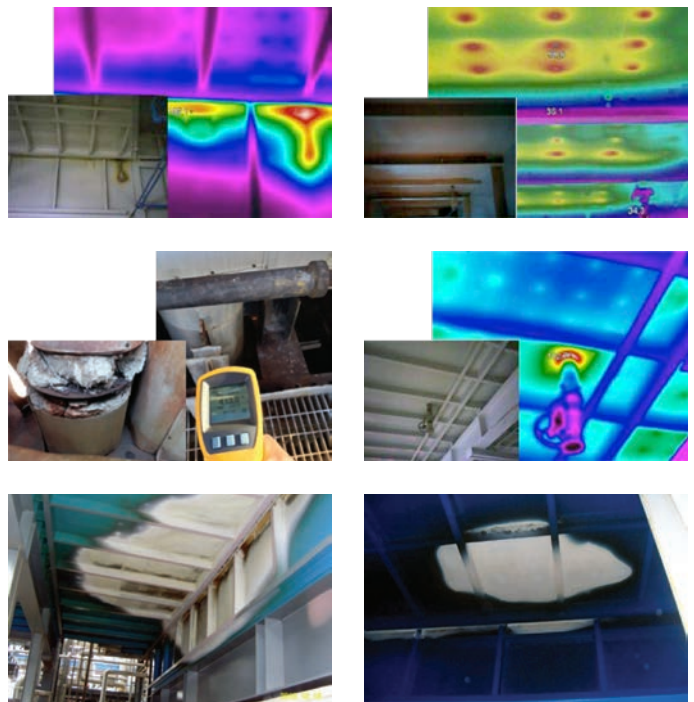
Figure 1: Casing Burn by Hot Gas Leakage from Damaged Liner Plate

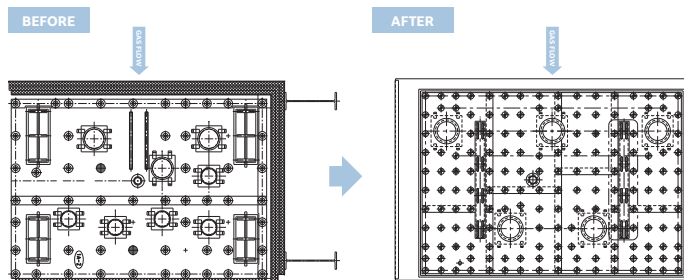
2. Liner Plate Modification

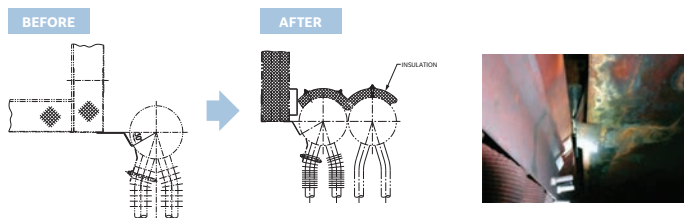
3. Gas Bypass Baffle Modification

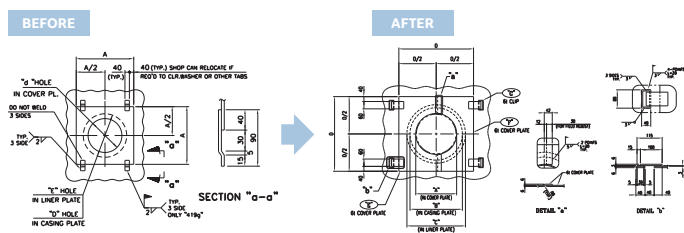
4. Cover Plate & Bent Clip Modification

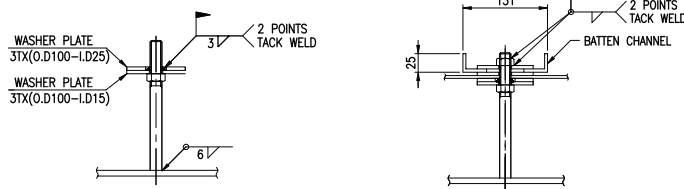
5. Reinforcement of Inlet Duct Bottom

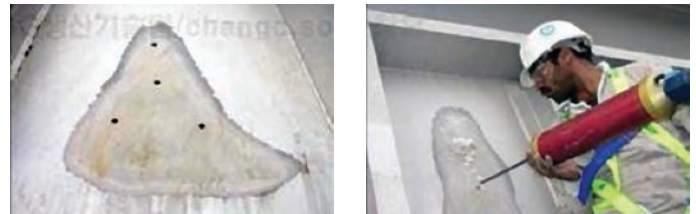
Figure 4: Re-Fill Insulation
