# APLETEC

## Restoration of Water Box Tightness

### Reduce Life-Cycle Costs of Generators

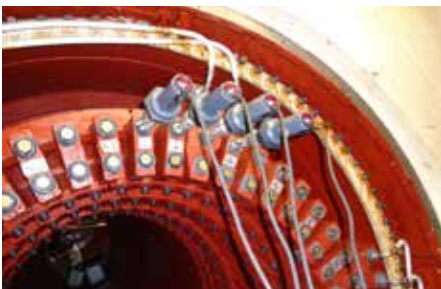
Water box being processed

First, the inner side of the water box undergoes chemical cleaning to ensure that surfaces are prepared for the resin bond.

Resin is injected into the water box, penetrating the interstices by capillary action. Circulation of clean air in the winding prevents blockage of the tubes by the resin. A curing cycle completes the process. The treatment is confirmed by an endoscopic examination and a pressure test.

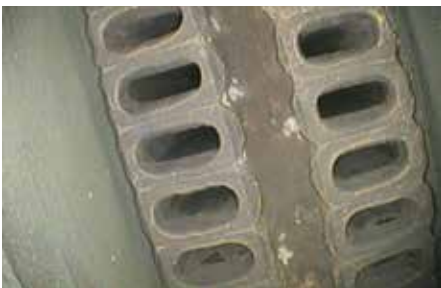
Water box being processed
