**AN EVALUATION
OF 15KV
OUTDOOR VOLTAGE
TRANSFORMERS**

JULY 1985

15KV INSTRUMENT TRANSFORMER TEST REPORT

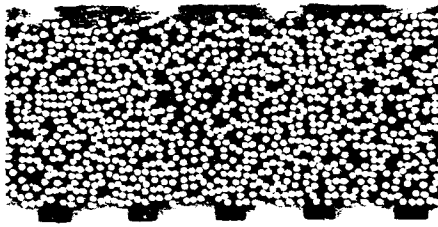
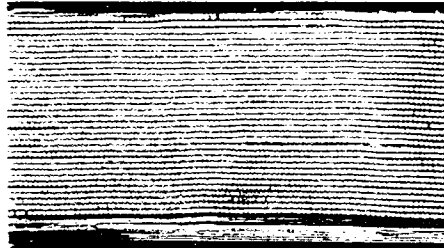
Cross Section of Primary Coil	Cross Section of Primary Coil	Cross Section of Primary Coil

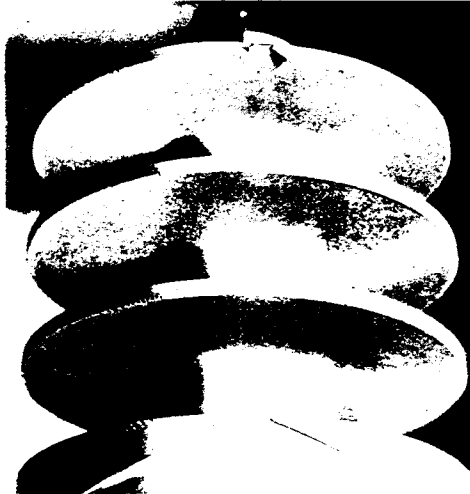
BALTEAU STANDARD
VEO1-110
DROP TEST RESULTS

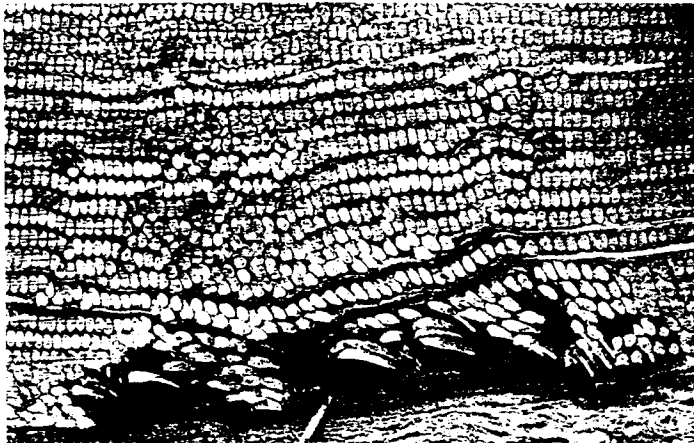
Teardown shows the primary coil to have two side by side sections with layer paper, cast and impregnated in epoxy. The impulse failure was found in the inner layers of one primary coil section. Winding impregnation appeared good except that there was circumferential evidence of a void coincident with the failure. This void may have contributed to (or resulted from) the failure and subsequent excitation.

Location of impulse failure within primary coil.

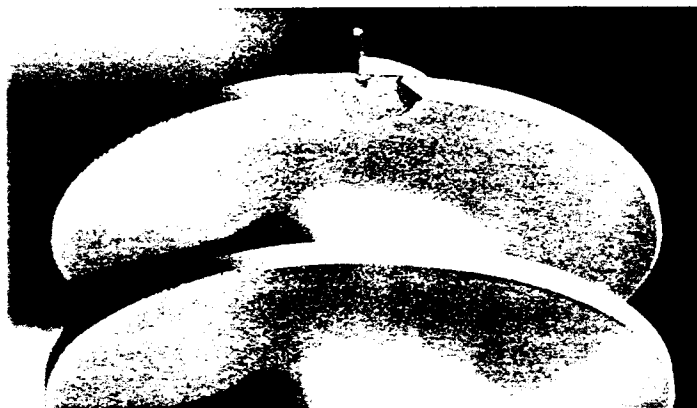
Chipped epoxy on top bushing skirt after 30"
drop test.

On the 15" drop test, a minor ($\frac{1}{4}'' \times \frac{1}{16}''$) epoxy chip occurred. On the 30" drop test, a substantial piece chipped off the top skirt. The piece was approximately $\frac{3}{4}'' \times \frac{1}{2}'' \times \frac{1}{8}''$ thick.

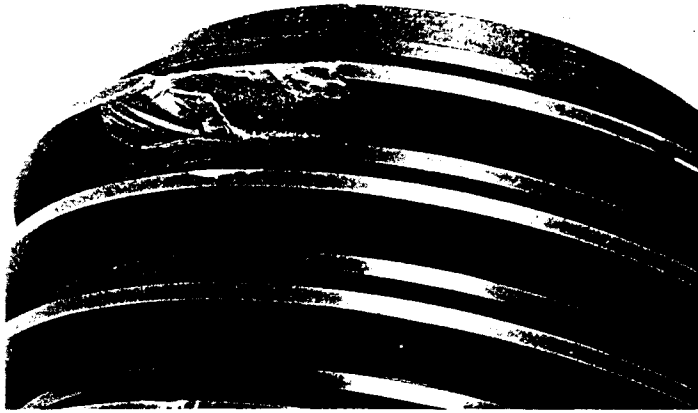
Drop test: Damaged. (Quantity tested—One (1))
On the 15" drop test, a minor chip occurred on the top bushing OD, and the H₂ connector separated from the base with a small adjacent chip of the epoxy. This "separation" involved partial failure of the solder bond on the portion of the H₂ strap protruding from the body. Electrical continuity to the base was maintained. On the 30" drop test, a

substantial piece of epoxy was chipped from the top major skirt, this piece being 2³/₄" x 1" x ³/₁₆" thick.

Epoxy chipped PO5-110 drop test damage
