**OIL TO SF<sub>6</sub> BUSHINGS SERIES POBR  
VOLTAGE FROM 72,5 TO 420 kV**

# STORAGE, OPERATING AND MAINTENANCE INSTRUCTIONS

IS 2651 GB  
Page 4/9

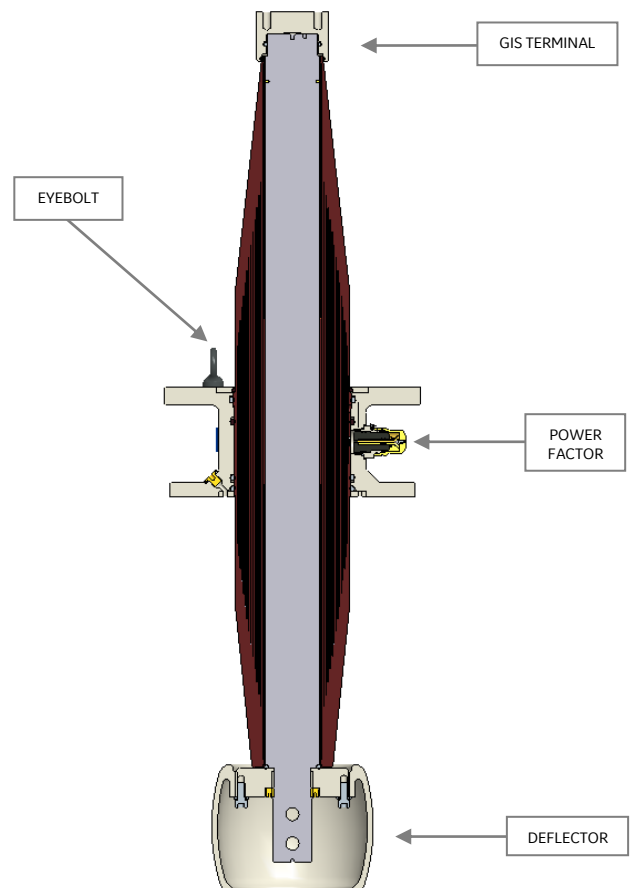
**Fig. 1**

These bushings are capacitance-graded type, resin impregnated paper type (RIP), designed for operation one side immersed in the transformer oil, the other one in SF<sub>6</sub> gas for GIS application.

The insulation core of the POBR is produced by winding crepe paper onto a central rod, with aluminium foil insert

for electrical stress control. The manufacturing process is optimized to give a partial discharge free bushing with low dielectric losses.

The schematic design is showed in figure 1.

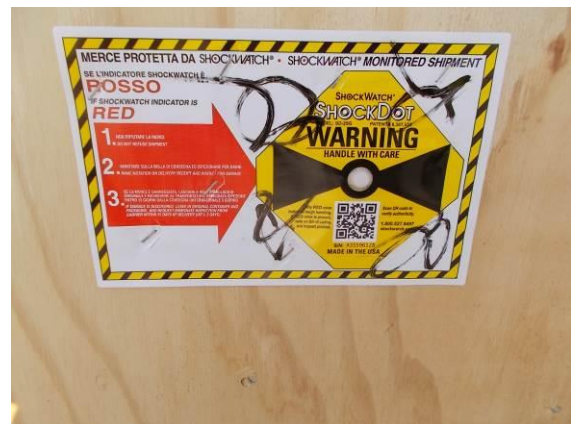
Fig. 3

- No sign of damage shall be found
- The shock-watch indicator, placed in the external part of each packing case (fig. 3), must be white.

If the shock-watch indicator is red, do not refuse shipment, make a notation on delivery receipt, and inspect for damage as follows:

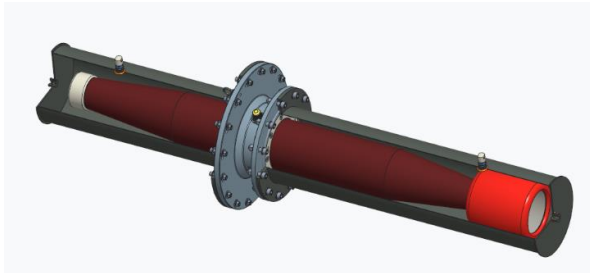
Fig. 4

- Concerning the storage of the bushing, the location (outdoor, rain protected or indoor) and the duration of storage (short, medium, or long term) must be considered. If necessary, a storage canister can be ordered to the manufacturer (fig. 4).

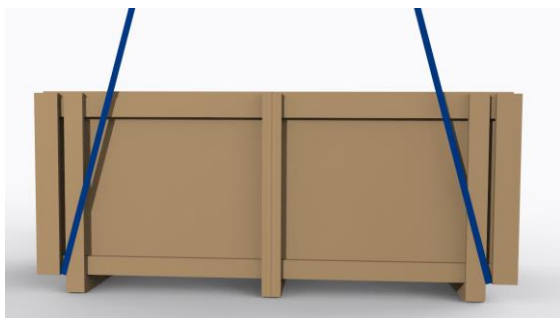
Fig. 6

The case containing the bushings can be easily lifted with a tackle by applying the ropes on the points and with a tilt as indicated in fig. 6. Some indications also appear in the packing case.

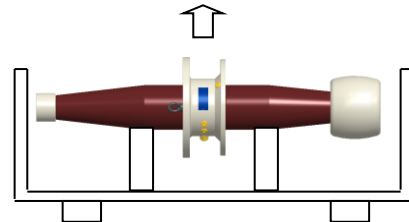
Fig. 7a

To take the bushing out of the case, operate as indicated in fig. 7a.

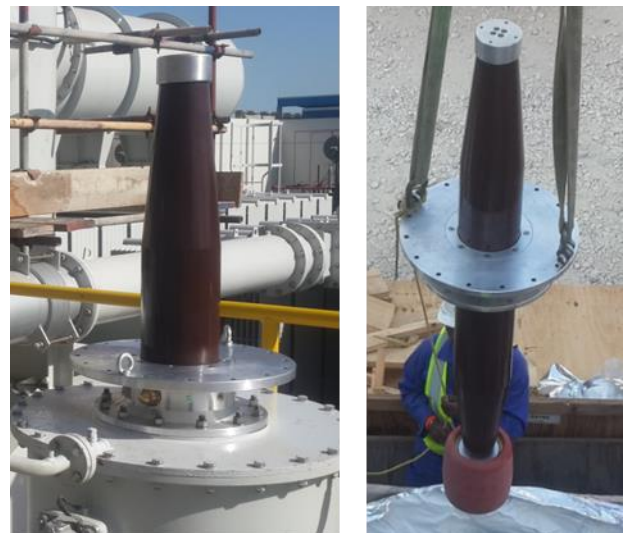
Fig. 7b

The best way to transport the unpacked bushing is keeping it in vertical position; be careful to place up the SF<sub>6</sub> side (the one starting from the larger side of the flange). To lift the bushing, it is necessary to use the holes placed on the rib between the two flanges (see fig. 7b).

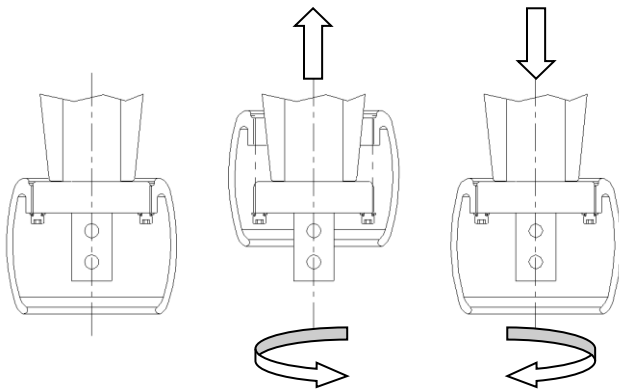
Fig. 8

The bottom end of the bushing is always shielded by a suitable aluminium insulated electrode. The shield has the function of increasing the dielectric strength in oil and screening the connection between the lead coming from the transformer winding and the bushing itself.

This deflector is removable to facilitate the connection between transformer cable and bushing.

- Deflector removable upwards: it can be unscrewed upwards (fig. 8).

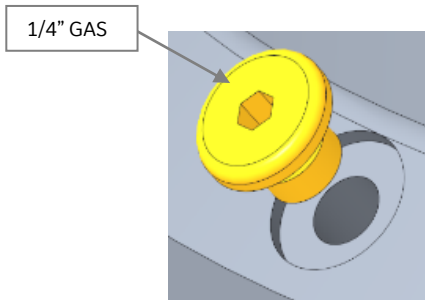
Fig. 9

A 1/4" GAS plug is placed on the bushing flange (fig. 9) in order to:

- connect the relay tube
- eliminate the air pocket which may have been formed during some executions and by filling the upper part of the transformer not under vacuum conditions. In this case we suggest unscrewing the plug and letting the air flow out. When oil starts to exit, please close it.

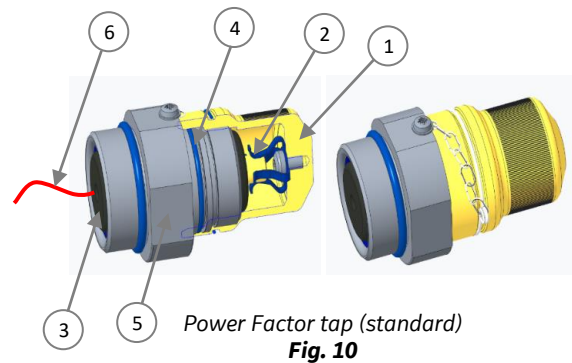
Fig. 10

During the operation, the connection tap must always be grounded. The PF tap is schematised in fig. 10.

1. Closing and grounding cap (removable)
2. Measurement electrode
3. Insulating bushing
4. Gaskets
5. Mounting flange
6. Last layer

It is advisable to check that the cap of the PF tap (see fig. 10) is well screwed. A forgetfulness of this generates during service a voltage on the tap that exceeds the insulation dielectric strength: this may lead to a catastrophic failure.

Don't unscrew the mounting flange item 5 of fig. 10: it fixes the PF to the bushing.
