# MID-LIFE CONDITION ASSESSMENT

## For Critical Oil-Immersed Power Transformers

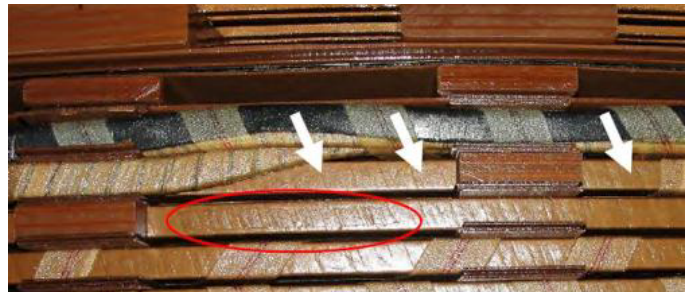
**Figure 3:** Paper sampling locations must be chosen according to the accessibility and rebuilt feasibility. Locations should be reasonably representative of winding temperature conditions or hot spot conditions.

Paper sampling at relevant locations (Figure 3) can complement the internal inspection.

The analysis of the Degree of Polymerization (DP) performed at the oil laboratory gives insights to evaluating the aging of the insulation, to identify any accelerated aging issue and estimate the remaining life time of the insulation for given operating conditions.

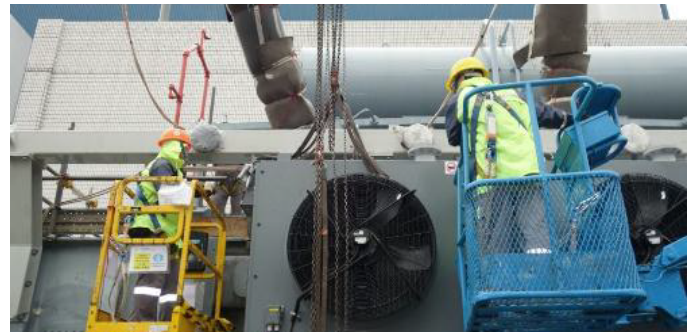
**Figure 4:** Improving cooling efficiency with upgrade of coolers and control cubicles on a 23 kV/435 kV three phases 420 MVA generator step up transformer.

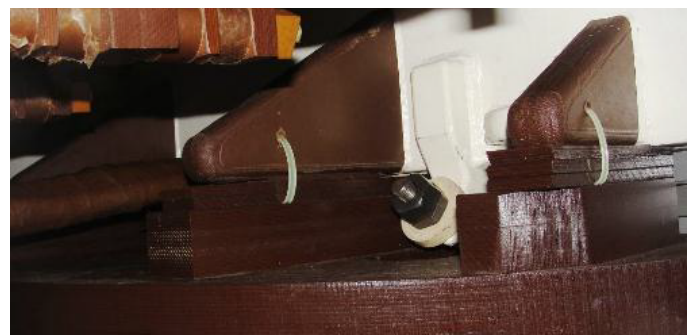
**Figure 6:** View of clamping brackets on LV side of one phase after the winding re-clamp. The photo shows how cable ties were used to secure blocks and shims.

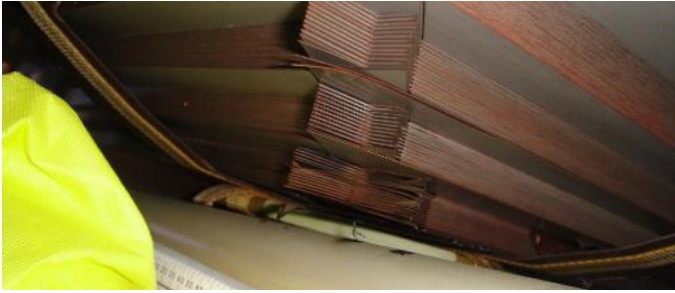
### Short circuit and circulating current damages

**Findings:** Short circuit and circulating current damages identified on core and core frame of a 19 year old large step down transformer 230 kV/10,5 kV.

**Recommendation:** Fault rectification with core and frame insulation and components repositioning.

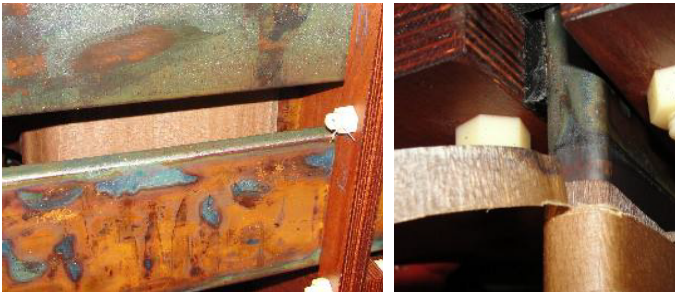
### Copper sulphide formation

**Findings:** Copper sulphide formed on copper busbar and in the wraps of the paper insulation on copper conductors.

**Recommendation:** Cleaning of copper busbars and replacement of paper impacted by deposit where accessible. Rinse of the transformer active parts to eliminate residual corrosive oil, oil reclamation and chemical treatment or oil change according to the transformer history of maintenance.

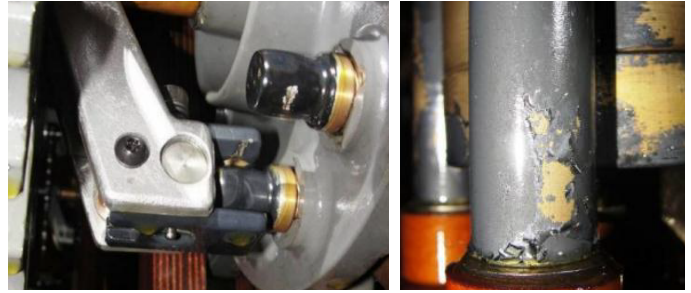
### Corrosive sulphur formation

**Findings:** Silver sulphide on de-energized tap changer of a large 35 year old 330 kV/138 kV/11 kV auto-transformer.

**Recommendation:** Cleaning, treatment, passivation, change of oil reclamation process or replacement according to extent of damage and history.
