# HRSG TUBE RESTRAINTS UPGRADE

**For Robust Design and Improved Reliability**

## **Improve reliability, reduce O&M costs and prevent consequential damage and tube failure.**

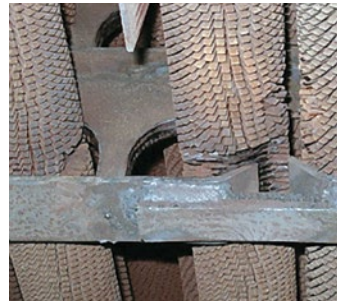
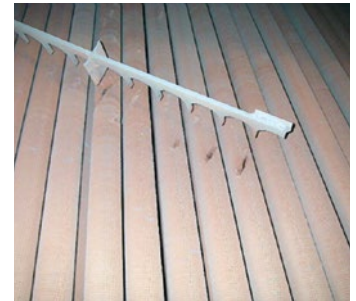
Figure 1: Fin wear from friction with damaged restraint

Tube restraint systems are constructed in different ways depending on HRSG manufacturer, however the exposure to high temperature and continual gas flow, leads to inevitable breakage of the restraint components including clips and supports. Furthermore, flexible plant operation exposes the restraints to high temperature transients increasing the risk of failure. This results in the restraints falling vertically, allowing tubes to move and bend. Eventually, the restraints will become ineffective and lead to tube fin wear and, in extreme cases, tube damage.

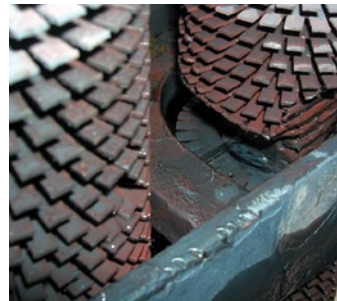
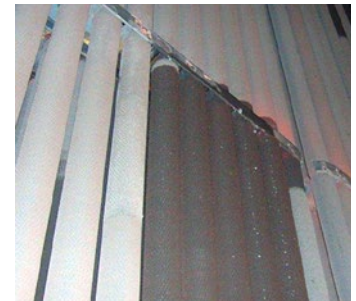
Figure 2: Leaking tubes from damaged restraints

Plant owners are typically faced with ongoing maintenance costs associated with routine repair of damaged tube restraints. Furthermore, damage to fins and tubes can lead to material loss sufficient to cause tube leakage and forced outages.

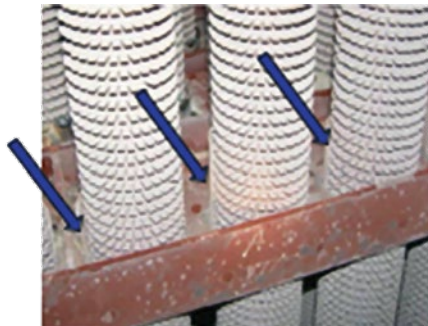
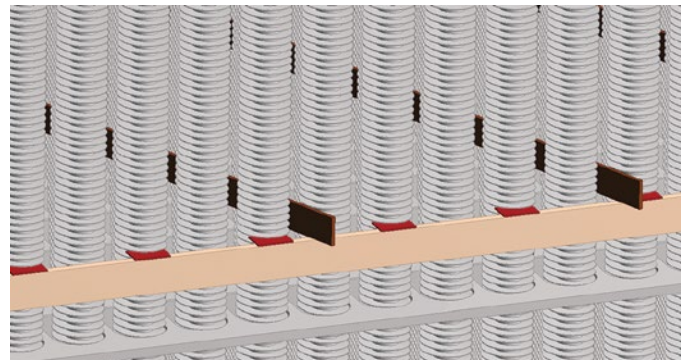
### 1. Tube Sleeves

This tube restraint replacement solution is applicable for restraint systems failures in the first two rows of a harp assembly.

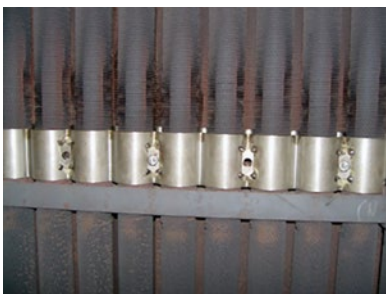
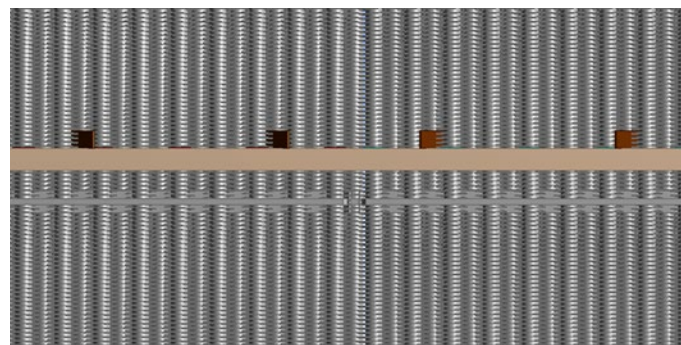
### 2. Wavy Bar

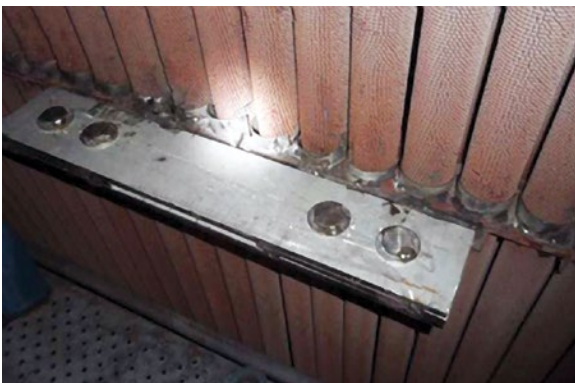
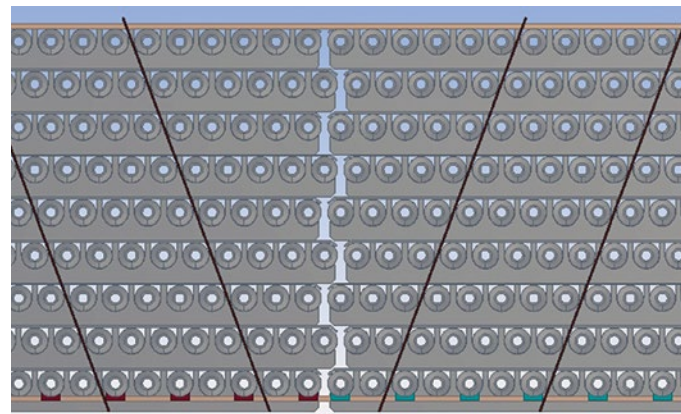
### 3. Sliding Bolt Type Tie Bar
