## UR Family

# Version 7.9x

## Release Notes

GE Publication Number: GER-4879F

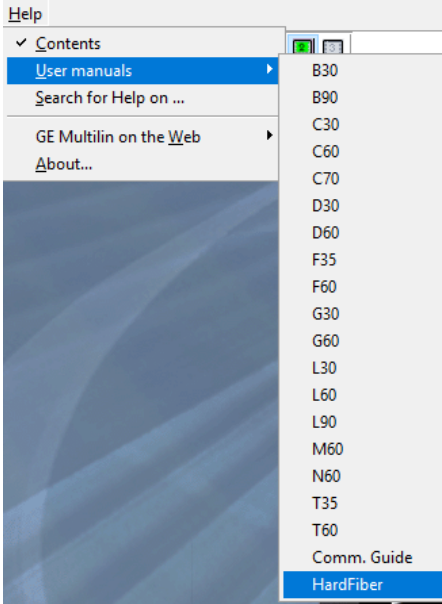
Category	Description
	Analog Input point 24' setting should have been converted, but it was set to 'OFF'. This is fixed in this release.
N	<p>Added HardFiber manual to software help files</p>

<p>The screenshot shows a 'Help' menu with 'User manuals' expanded. The expanded list includes: B30, B90, C30, C60, C70, D30, D60, F35, F60, G30, G60, L30, L60, L90, M60, N60, T35, T60, Comm. Guide, and HardFiber. 'HardFiber' is highlighted at the bottom of the list.</p>
E	Fixed issue with L90 conversions between devices with different numbers of Direct IOs, from v1 $\geq$ 7.70 to v2 $\geq$ 7.70, where some 'Direct I/P 1-%d On' operands were shown as 'Direct I/P 2-%d On', while 'Direct I/P 2-%d On' operands were shown as 'Direct I/P 1-%d On'. The fix also ensures that the correct number of Direct I/O channels, the correct number of elements, and the value ranges are shown after converting.
E	Corrected display issues in the graphical view of the FlexLogic Equation Editor in Japanese, where <ol style="list-style-type: none"> <li>'END' text was cropped inside the symbol.</li> <li>'END' text should not be displayed in Japanese.</li> <li>The values on 'Timer' were cropped.</li> </ol>
