## UR Family

# Version 8.1x

## Release Notes

GE Publication Number: GER-4903D

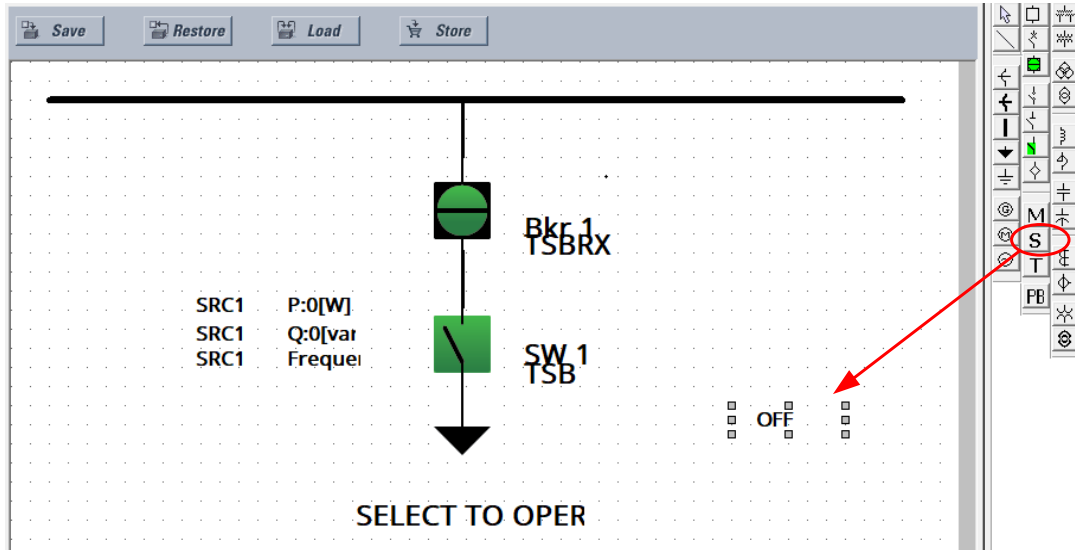
Diagram Editor windows in the EnerVista UR Setup software. After synchronizing these screens to the UR, the graphical front panel shows the actual status value for each of the Status components. In previous versions, this is achieved by adding/editing Status components in the single-line diagram screen of an online device, not when adding/editing the components in offline devices that were subsequently synchronized to UR.

In the new release, this configuration is included in CID files, allowing relays to show the actual status value for each of the Status components in their graphical front panel screens.
