GE MDS

**Upgrading OCR Firmware**  
**OCR: 3.9.26**  
Tom Mayo  
11/12/2008

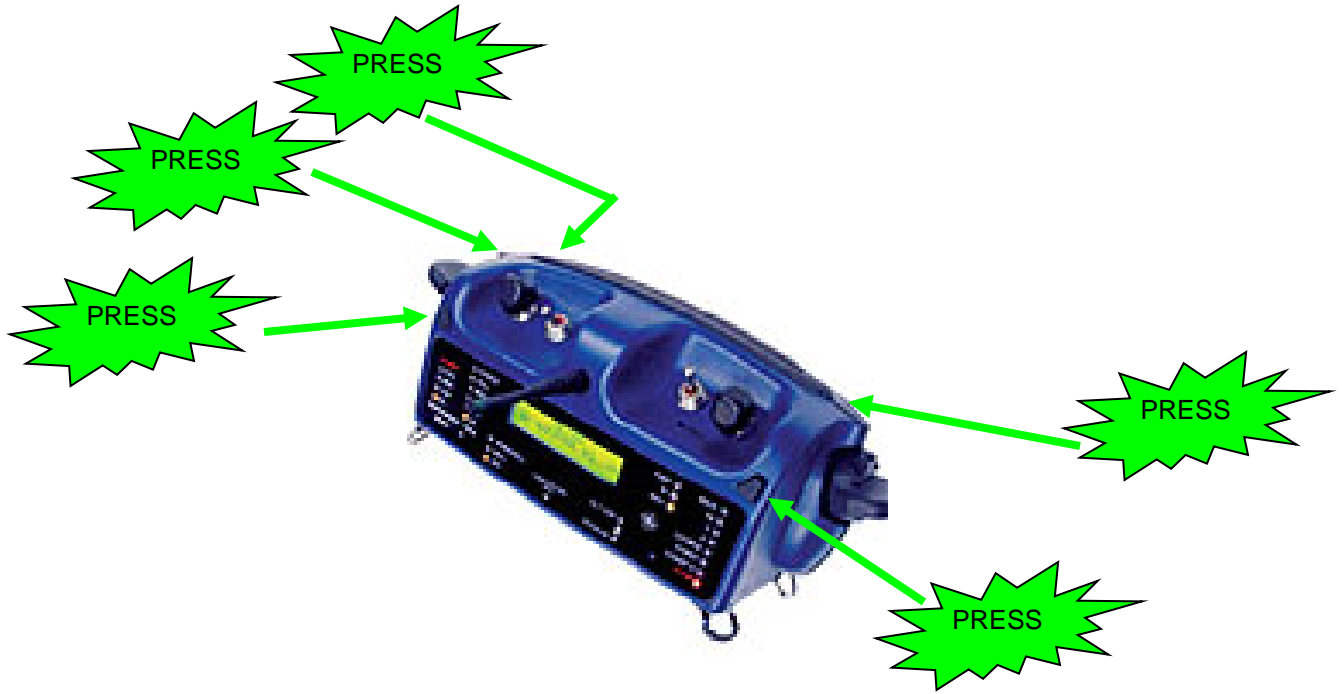
Figure 1: Activating IR OCR Console Access

1. Turn on the OCU, then activate IR OCR console access by depressing the 5 buttons shown in Figure 1 simultaneously.
2. Use a serial to IR dongle to access the OCU's infrared serial port as shown in Figure 2. Use 57,600 baud rate.
3. Log in to the OCR.
4. Execute the DEVICE command and record the results.

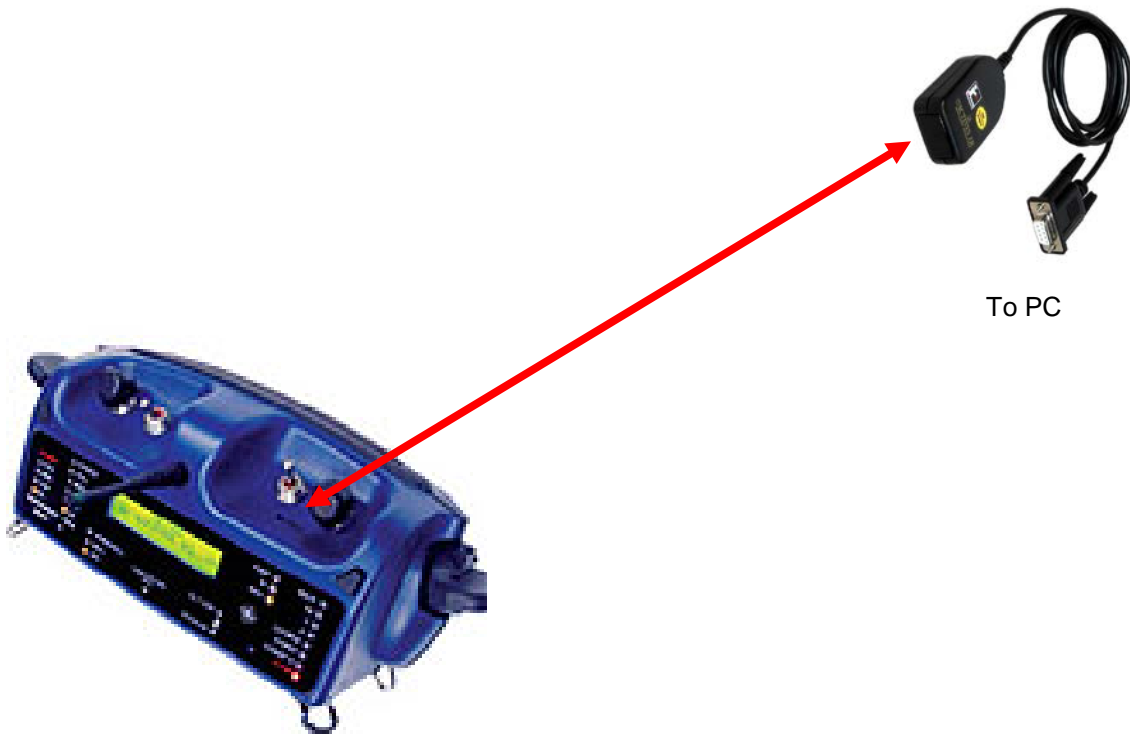
Figure 2: Accessing the OCU's Infrared Serial Port
