MM300 Motor Management System

Firmware Version 1.71 Update

Release Notes

GE Publication Number: GER-4827
Copyright © 2018 GE Multilin Inc.

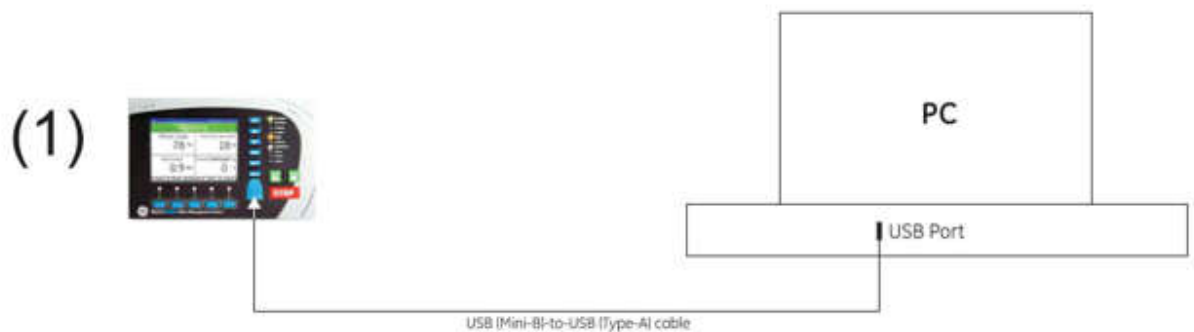
The MM300 Graphical Control Panel (GCP) or Hand Held Device (HHD) must be used for this update. Connect the USB port on the front of the MM300 relay, to the USB port on the local PC, using a USB 2.0 type A to mini B cable. This configuration (1) is shown below.
